Tunncliffe Timber Company Limited

## The Myth about Primer

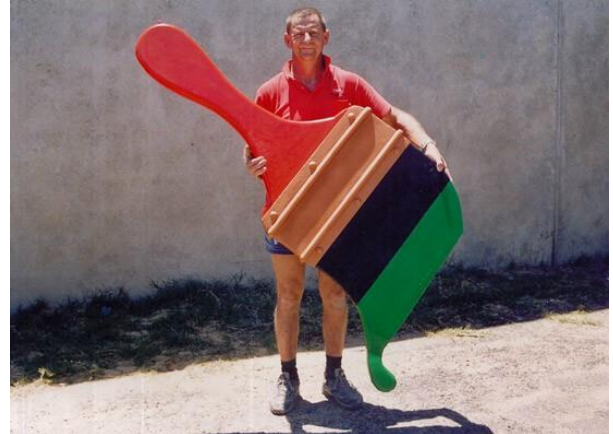
Exterior timber windows and doors getting wet during the building process can cause major problems in the way of bowing and twisting and in some cases cracking. The most vulnerable parts of the joinery are the window-, and door-sills.

The problem occurs with the majority of timber species, yet is a common problem with Radiata pine which is mainly used for the frames; jambs, sills and mullions.

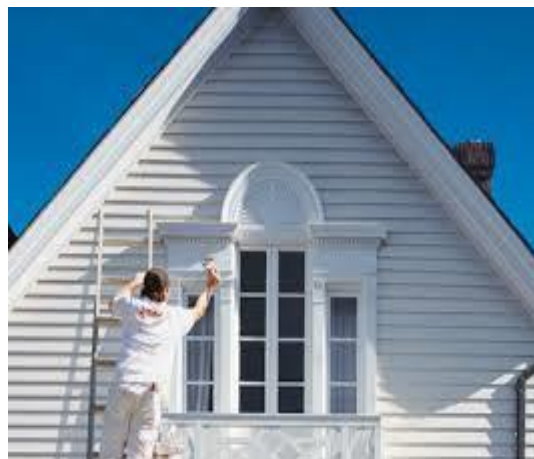
What in fact needs to be sealed off are very small openings on the surface of the Radiata pine timber components which cannot be seen with the naked eye, you don't need a microscope but with a reasonable magnification glass you can see "resin canals", which are designed to transport water and nutrients between the wood cells, in horizontal direction, at the time the timber was part of a living tree. If you have a close look, you can see thousands of needle-pin-holes.

Water is easily absorbed through these pin holes in liquid form. A minimum of two quality coatings of finishing paint prevents this from happening. It should be noted that the best way of applying the coatings of paint is with a brush because the forces at the tips of the bristles are working the coating into these pin holes which are hard to fill up. Spray coats in situations where there are many resin canals won't necessarily fill these up.
